CASE STUDY 5

OVER THE TOP

Medway NHS Trust are constructing a new Ophthalmology ward in the grounds of Medway Maritime Hospital at Gillingham, Kent. Due to numerous underground services and some poor ground conditions within the site area it was specified that piled foundations should be installed. So far so good!

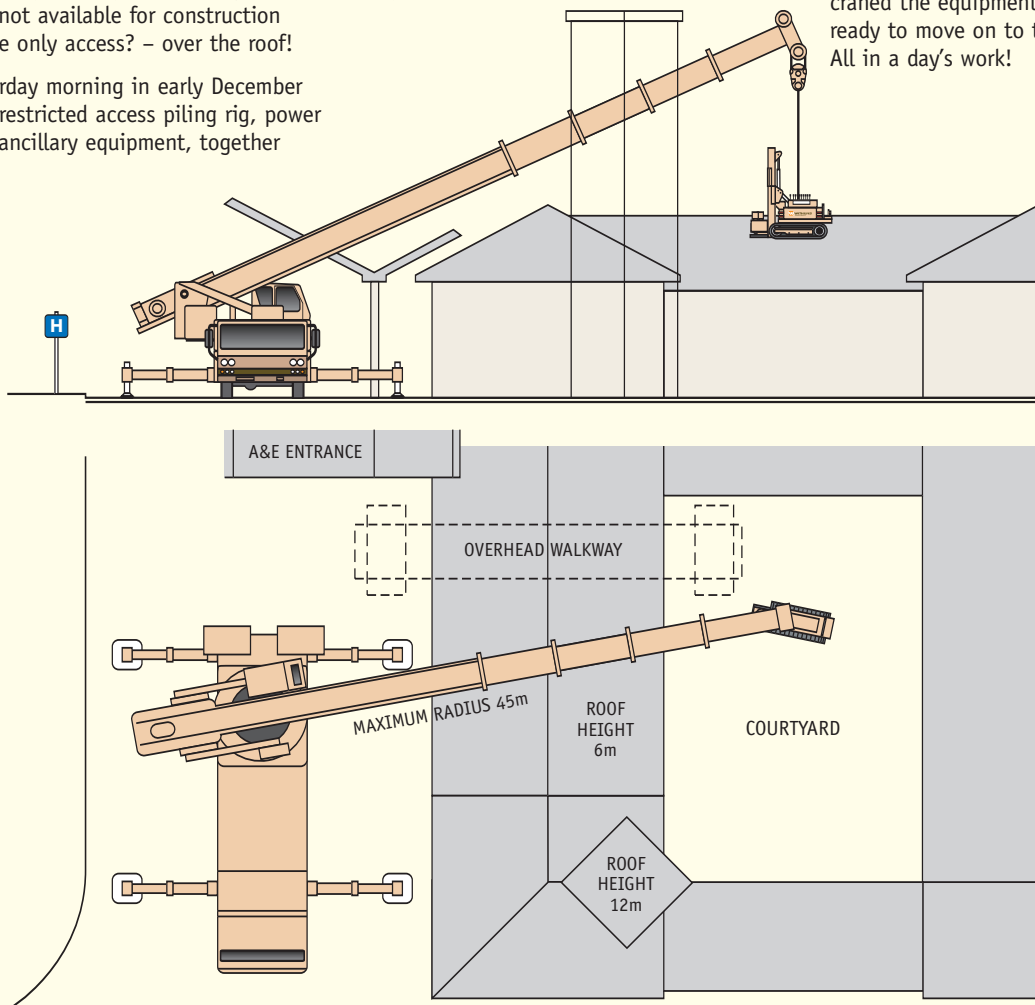
On a Saturday morning in early December 2004 our restricted access piling rig, power pack and ancillary equipment, together

with 30 tonnes of sand and 15 tonnes of cement were craned over the hospital roof using a 100 tonne mobile crane. This operation took approximately 45 crane lifts.
